Sample School District Air Leakage Inspection Report

Building: School District Buildings

Submittal
Date: May, 2017

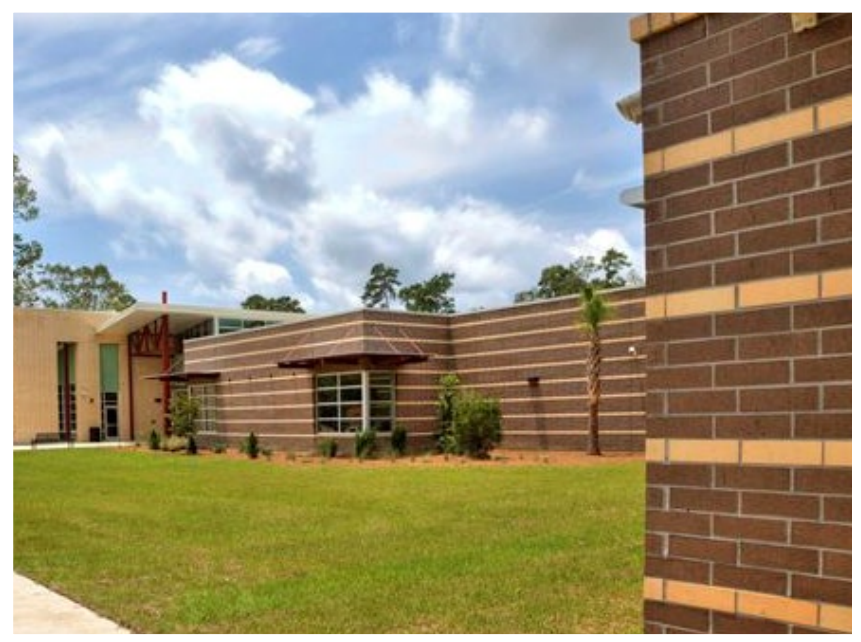
- A. School Building.
- B. Mechanical Curb - Capped: The mechanical curb has been capped, however, the perimeter requires sealing to prevent migration of air infiltration/exfiltration.

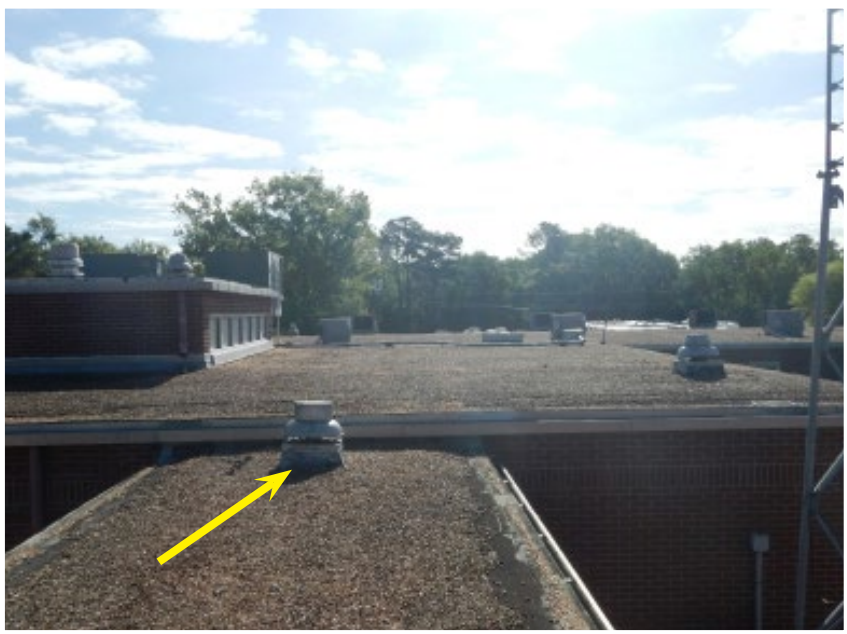
- C. Roof Exhausts: There are many roof exhausts on the school and they all require the curb-to-duct to be sealed. The gap around the curb-to-duct is allowing air leakage.
- D. Roof/Wall Front Entrance: The air leakage detector is showing that inside conditioned air is migrating out of the school. Cobwebs and dirt are an indication that air leakage is occurring.

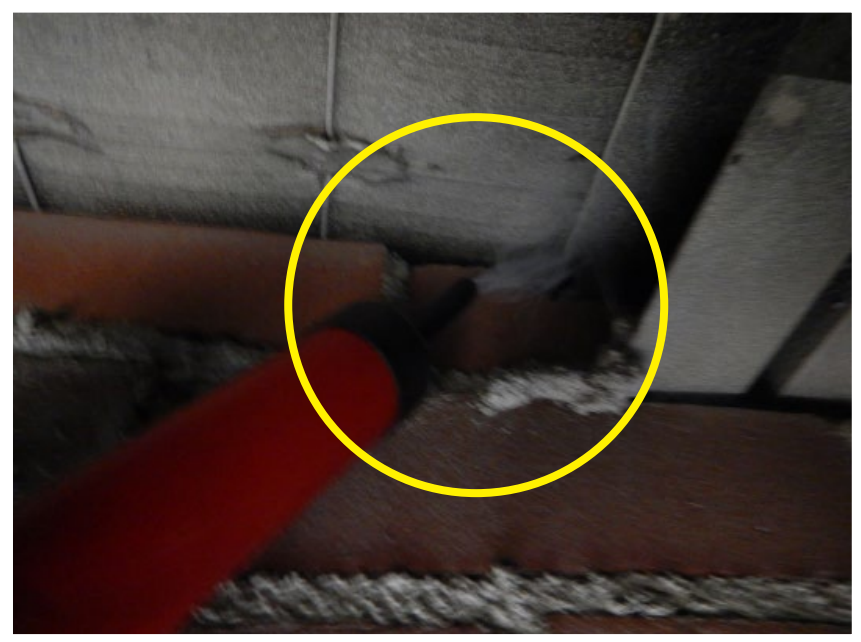
- E. Roof/Wall Intersection: This is another detail of the roof/wall intersection. The smoke is escaping, which is also bringing the conditioned air along with it.
- F. Typical Window System: This style of window system is representative of the majority type of window system in the school.

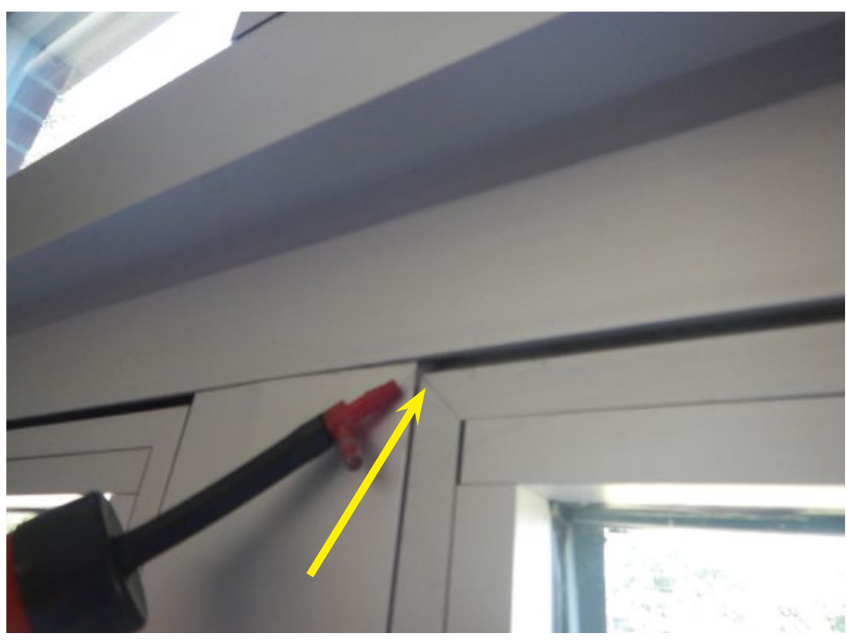
- G. The windows have dropped slightly allowing a small gap at the tops of these systems. New weather-seals installed at the tops will rectify the issue of air leakage.
- H. Double-Hung Windows: This type of window appears to be in good condition, as was noted when tested with the air leakage detector.

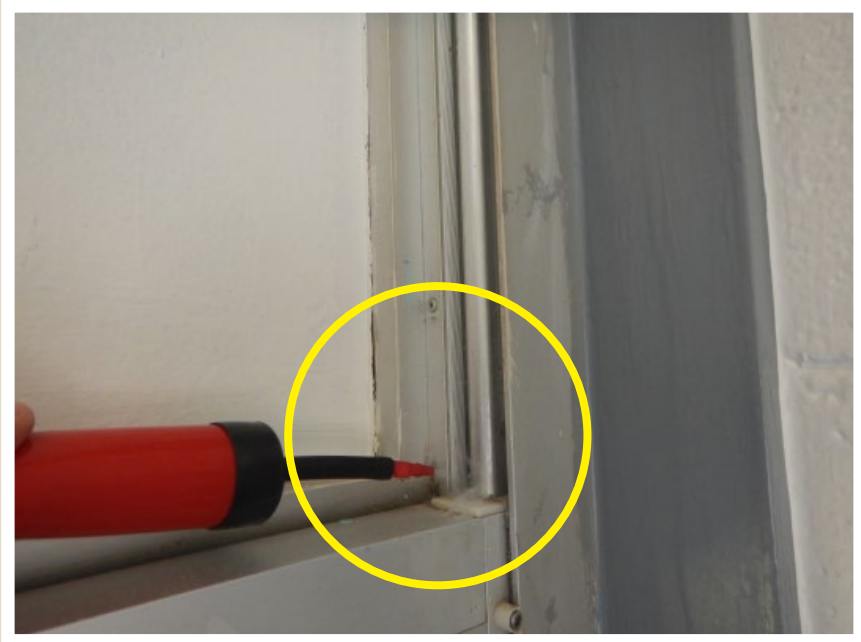
- I. Another photo showing the double-hung window being tested with the air leakage detector.
- J. Window Mullions Above Drop Ceiling: The mullions are opening which is allowing air to migrate into and out of the school.

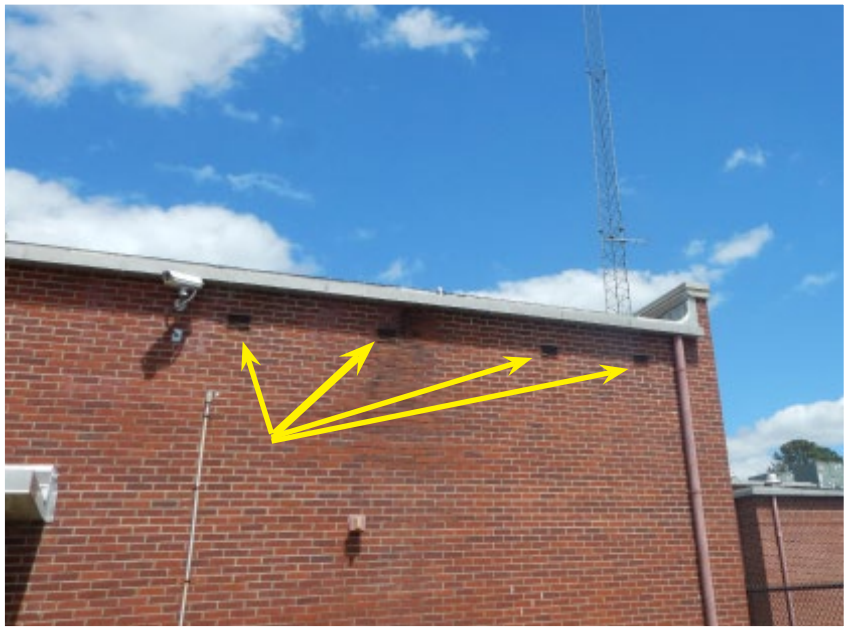
- K. Cafetorium - Above Drop Ceiling (exterior view): There are many old vents above the drop ceiling that need to be blocked off and sealed. The vents are allowing the migration of moist air into the school as well as the conditioned air to escape.
- L. Cafetorium - Above Drop Ceiling (interior view): The vents are open to the interior, approximately 30 vents in total. 15 on each side of this area.

Old Vent Grills (Cafetorium)	Poor, grill vents are allowing air migration into and out of the school	Block off and seal with an insulation board and foam sealant
Exterior Doors	Poor, worn or missing weather-seals	Install high-end, longer lasting weather-stripping

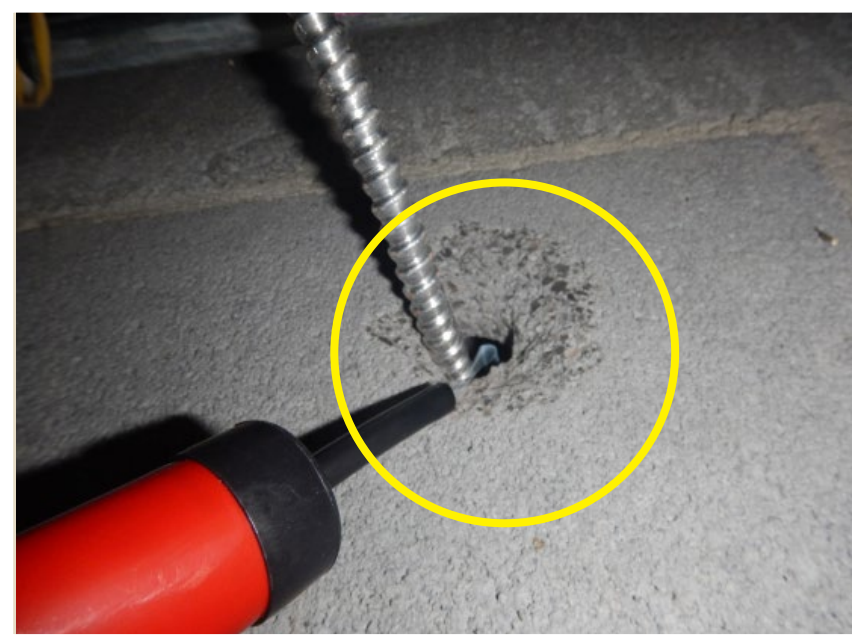
M. Conduit Penetration to Exterior: The air leakage detector is showing that the inside conditioned air is escaping around this hole.

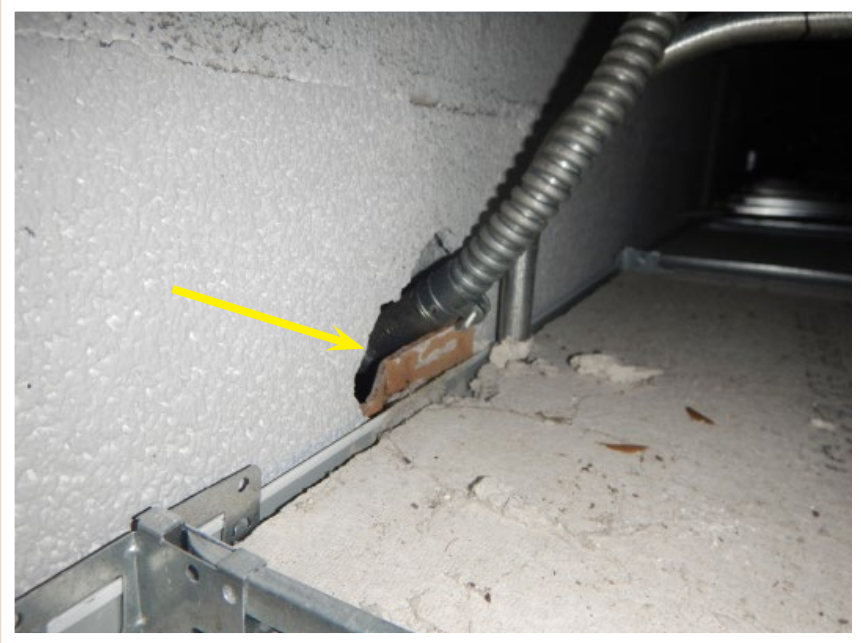
N. Photo shows another conduit penetration, a source of air leakage, that needs to be sealed.

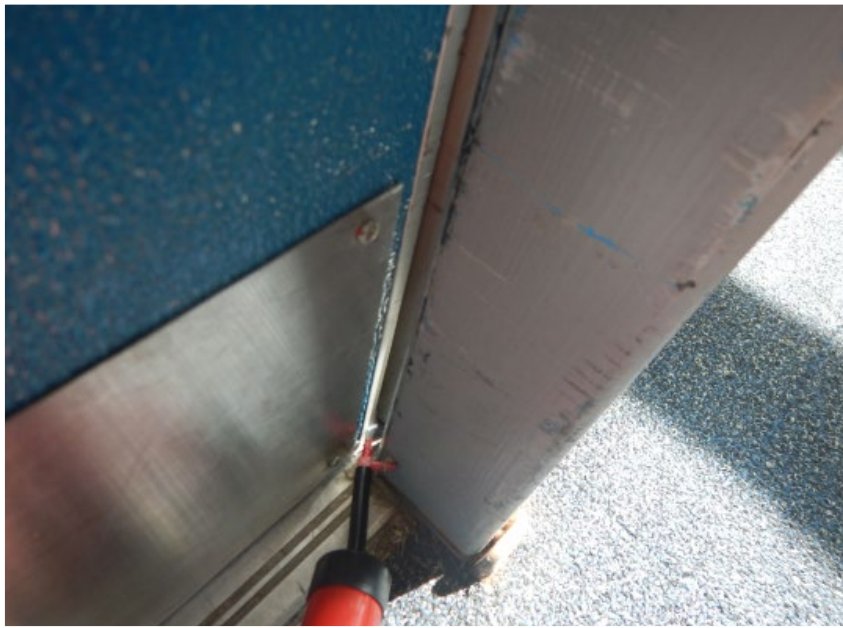
- O. Front Entrance Doors:
The air leakage detector shows that there is air leakage between the door as well as at the tops of these doors, which is leaking the inside air to the outside.
- P. Photo shows the door being tested with the air leakage detector. The building is under negative pressure and is pulling in the outside, unconditioned air.

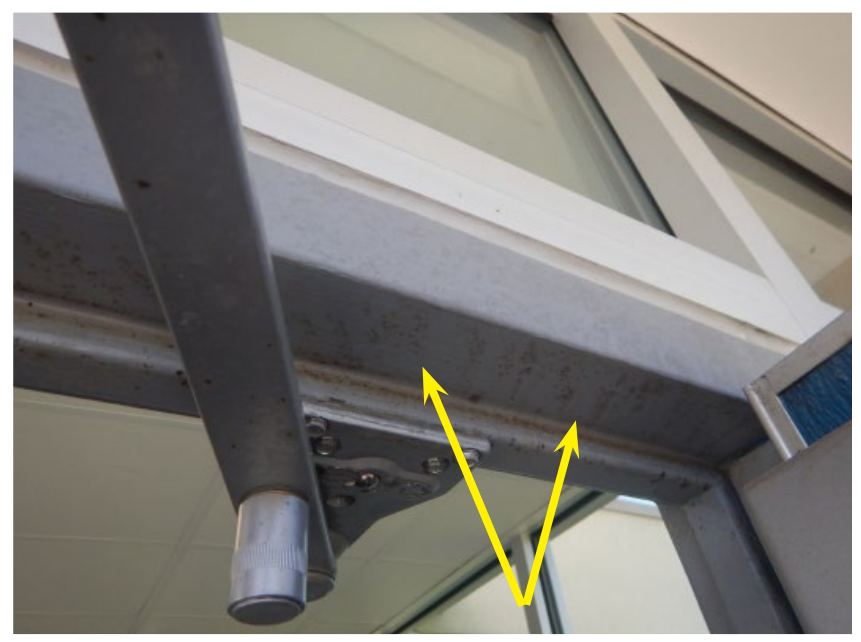
- Q. The dirt lines around the frame are more evidence of air infiltration/exfiltration into and out of the building.
- R. Exit Door (Double): This is the typical type of door system found in the school. The door bottom sweeps have worn as noted by the daylight under the door.

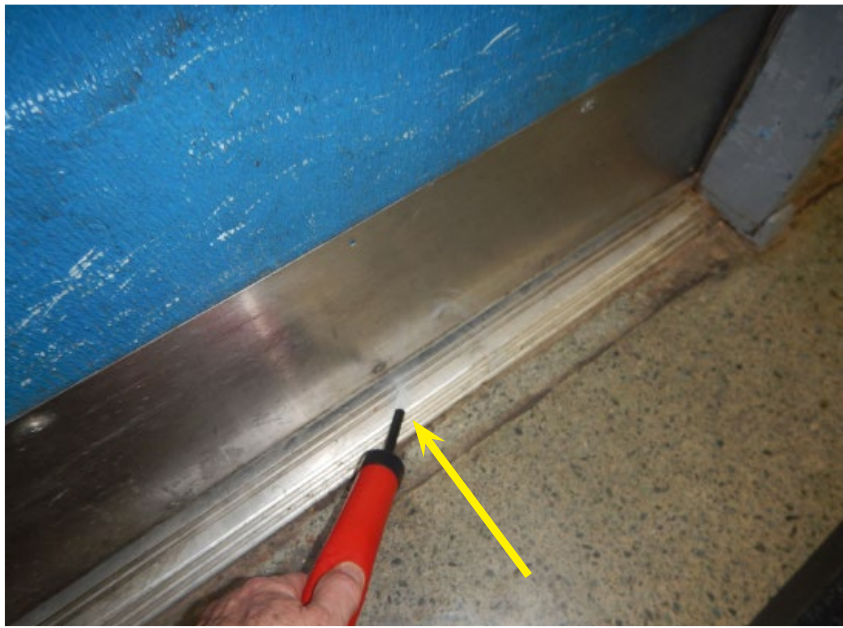
- S. Testing the double door bottom with the air leakage detector indicated that outside moist, unconditioned air is entering into the school at this detail.
- T. Air is escaping at the top side of this entry door.

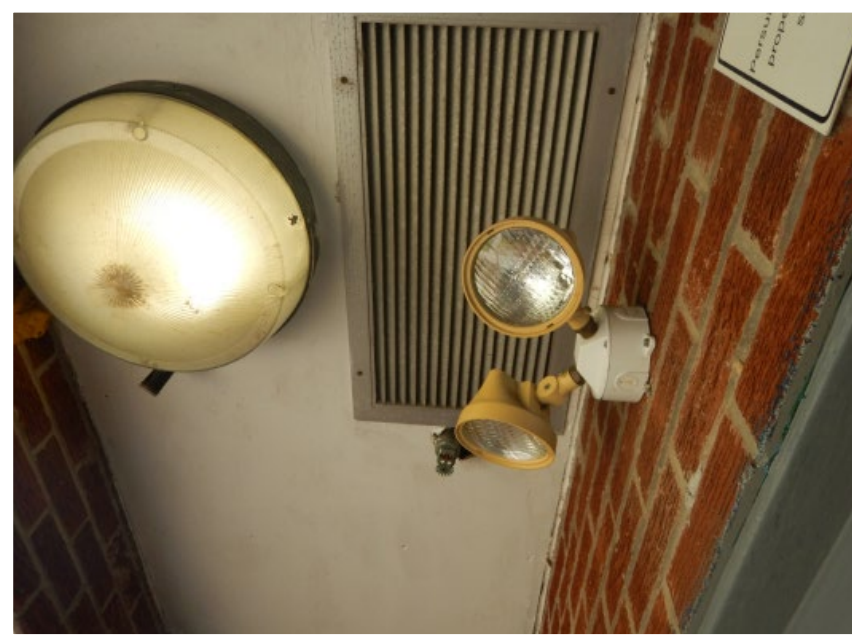
- U. Soffit Overhang at Door Entrances (exterior view):
The soffits at the door entries all appear to be open to the conditioned space above the drop ceilings.
- V. Soffit Overhang at Door Entrances (interior view):
From inside you can look into the soffit that is on the exterior, as well as there is a large vent connecting both in to outside. This can bring in a lot of moisture which will cause issues like ceiling tiles bowing.

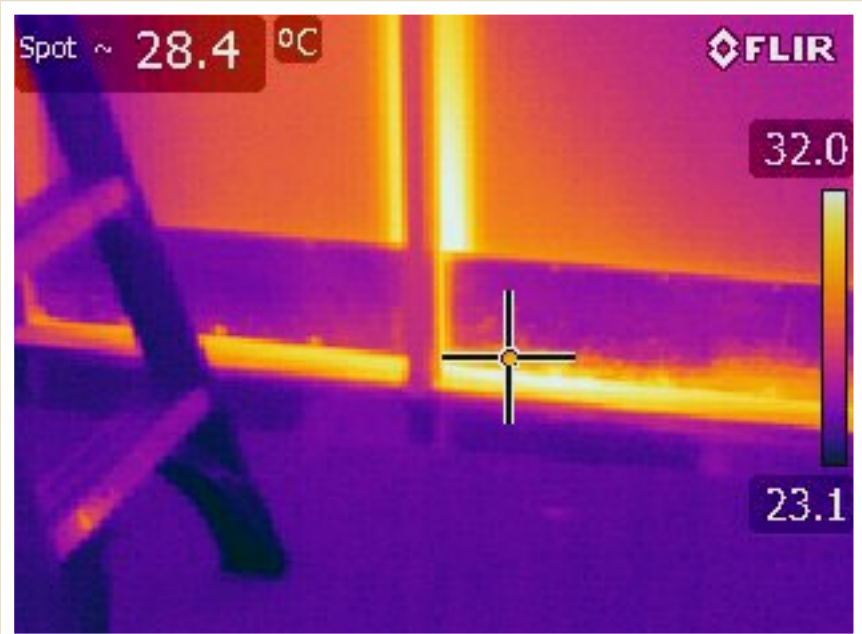
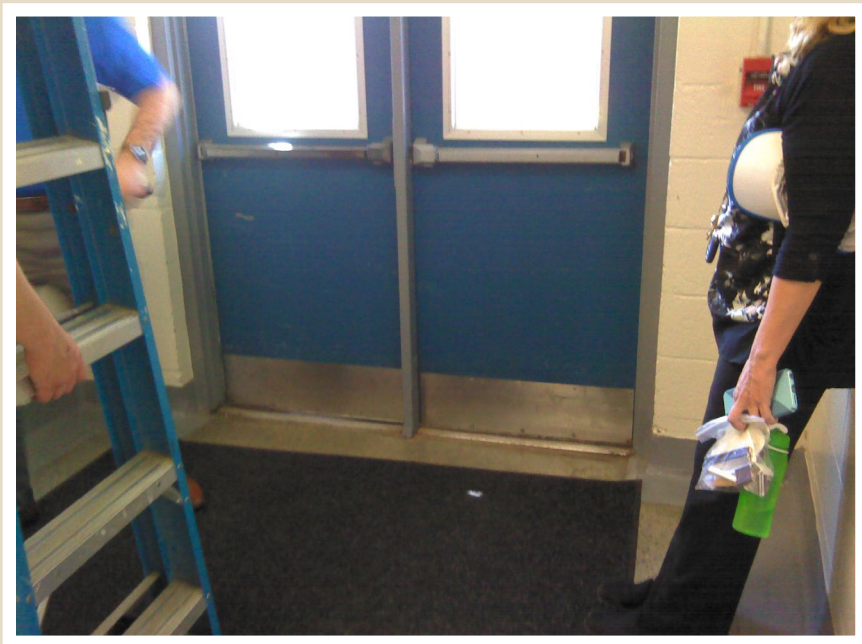
IR-A. IR of Entry Door: Thermal difference around the perimeter of this door confirms air leakage.
