Job Site Inspection Report

ABC Company

Main Building
549 West Street
Toronto, Ontario

Title Job Site Inspection
Date Recorded March 09, 2017
Type Inspection
Status Completed

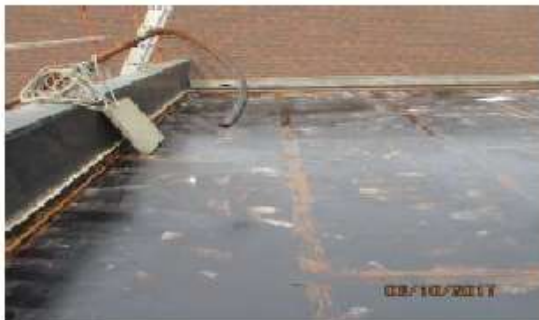
Layer of gypsum was applied as the new sub-decking. The joints were taped to assure no debris or otherwise could enter the building.
The surface of the gypsum was primed and ready for the vapour barrier.

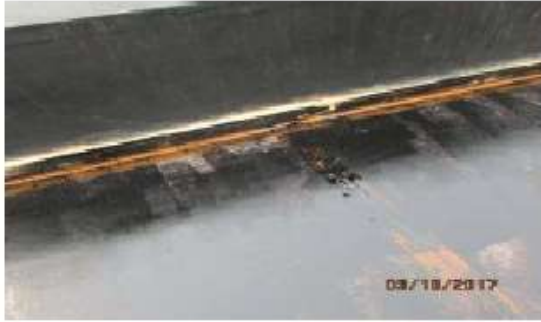
All openings within the gypsum are sealed with tape.

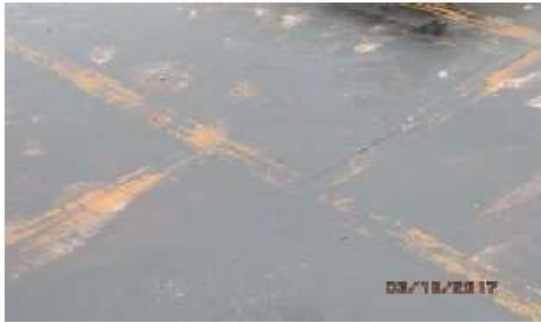
All openings within the gypsum are sealed with tape.

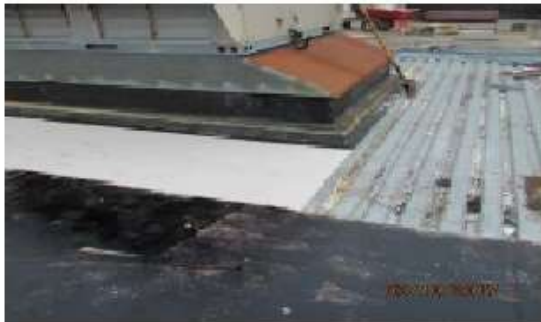
New gypsum being installed.

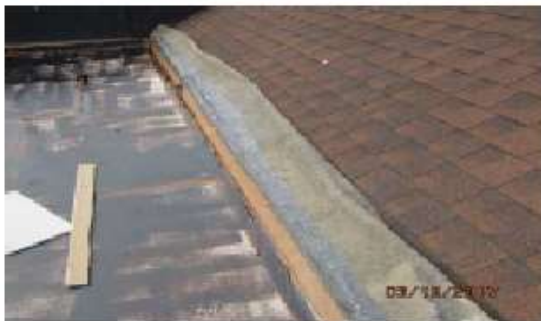
All openings within the gypsum are sealed with tape.

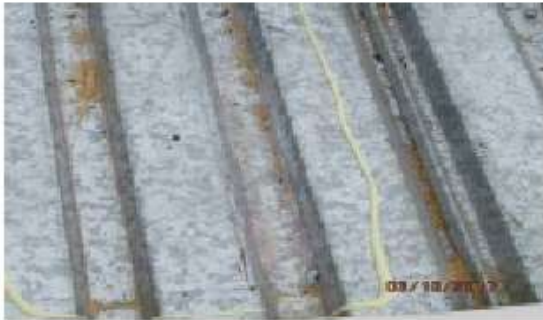
Flutes of decking are being cleaned out.

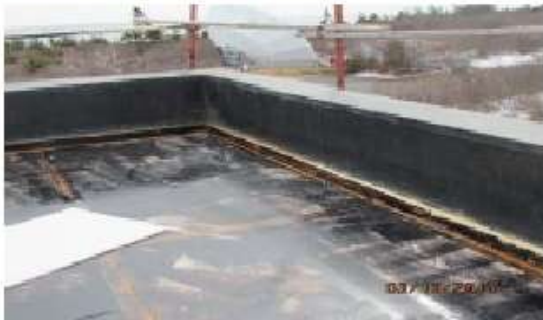
View of roof along parapet wall.

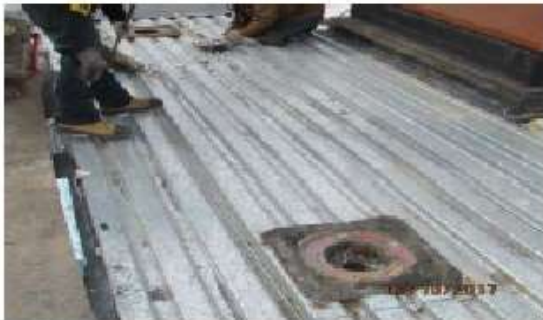
Flutes of decking being cleaned out.

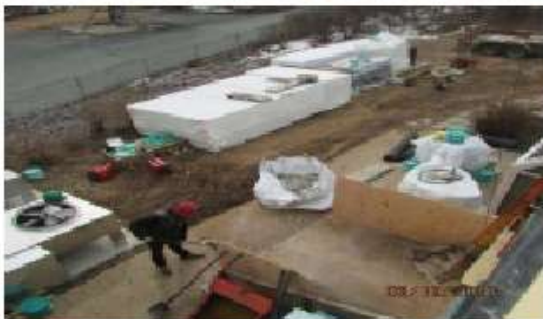
View of site from roof. Worker cleaning up as they proceed.

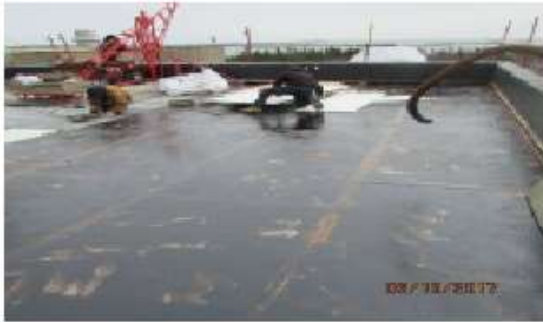
View of roof surface.

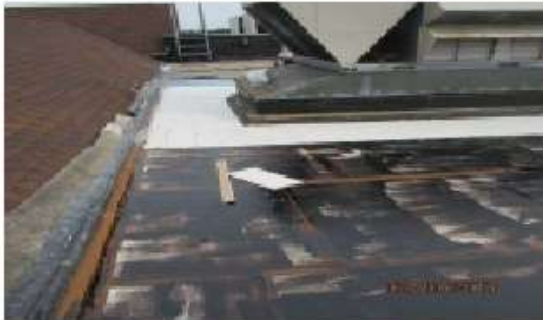
New gypsum being installed.

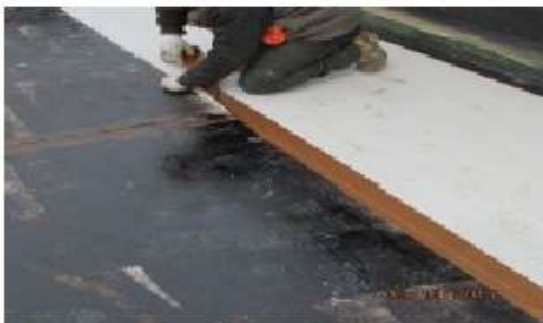
Joints of gypsum boards being sealed with tape.

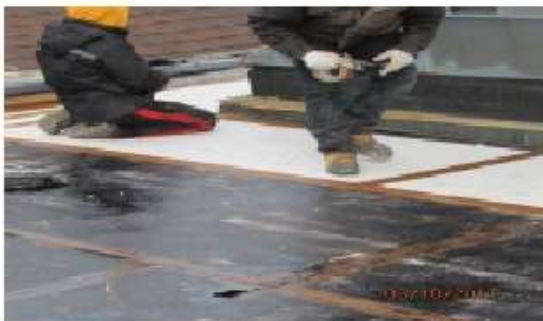
Joints of gypsum boards being sealed with tape.

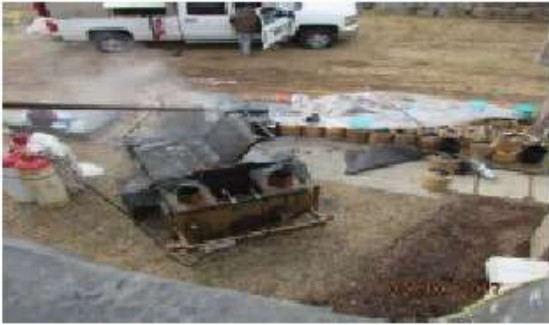
Work site below the roof.

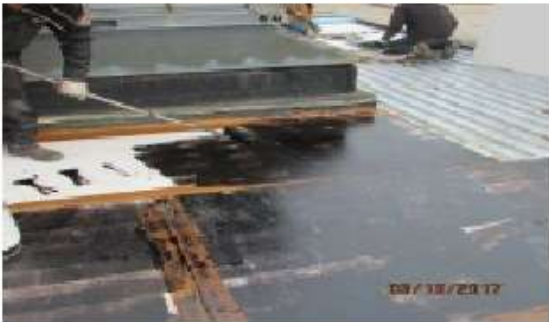
Priming gypsum surface.

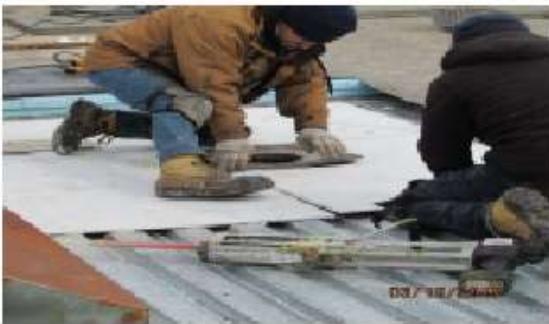
Installation of gypsum around roof drain.

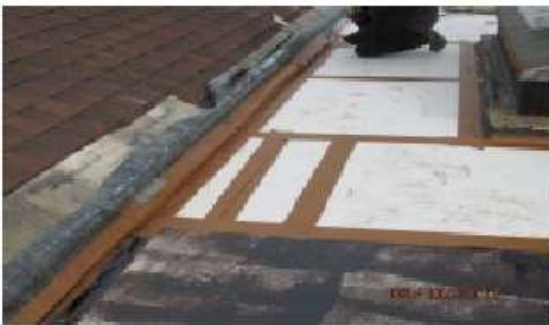
Joints of gypsum boards being sealed with tape.
