## GENERAL INFORMATION

Roof Name	Roof 01.1 (L2)
Service Activity Type	No
Service Activity Date	
Year of Installation	
Installing Contractor	
Roof Leaks	
Roof Size	5,130 sq. ft. 476.77 sq. meters
Roof Type	PVC
Roof Rating	Fair

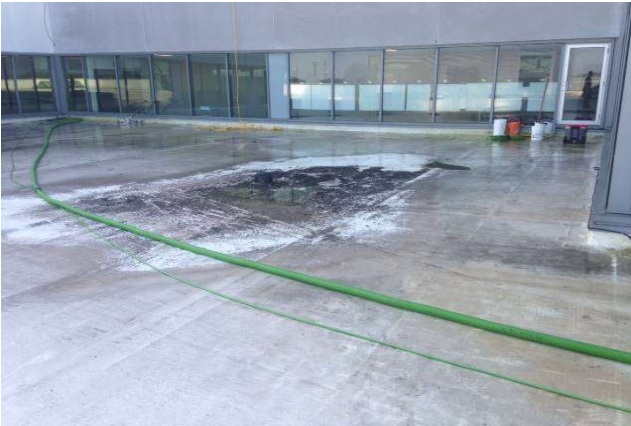
View of Roof 1.1 prior to being cleaned.

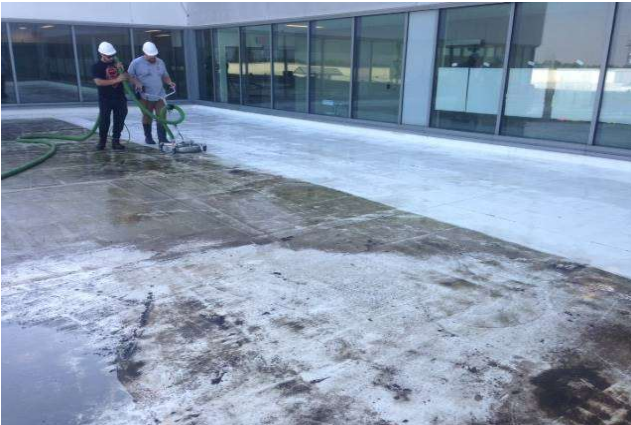
Overview of the roof in the process of being cleaned.

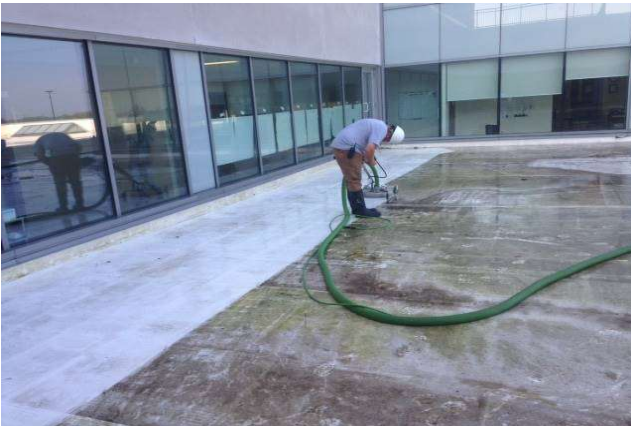
Another view of the roof being cleaned,

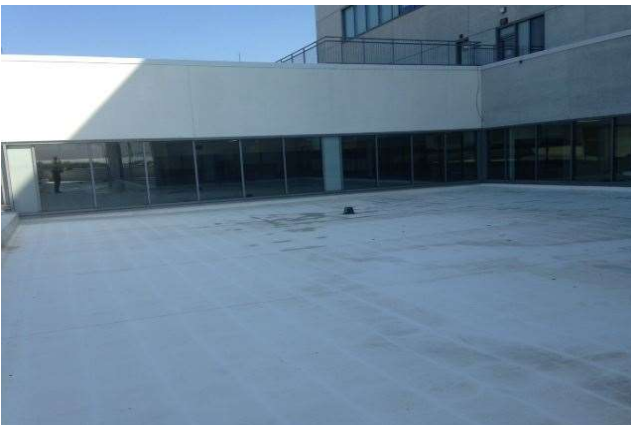
Overview of Roof 1.1 with the roof cleaning complete.
