# Sample Report

### SkyBEAM Roof Diagnostic Survey Report

Building ABC  
Street 123  
City, State

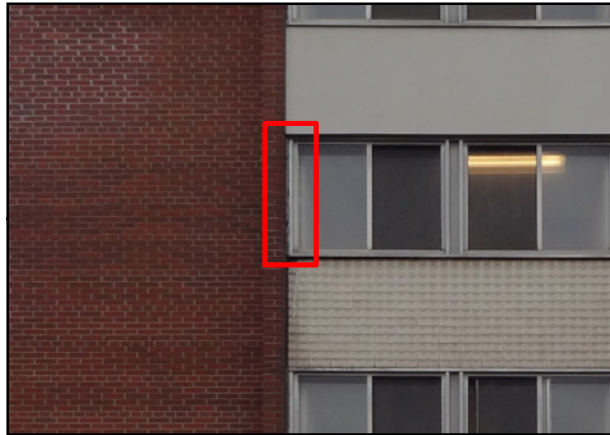
#1: Caulking failed

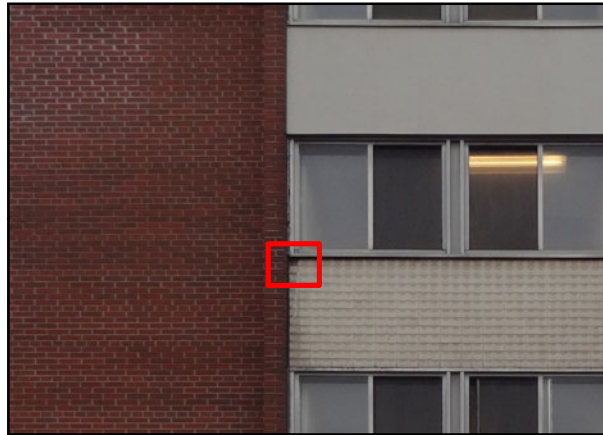
#2: Tiling is falling off.

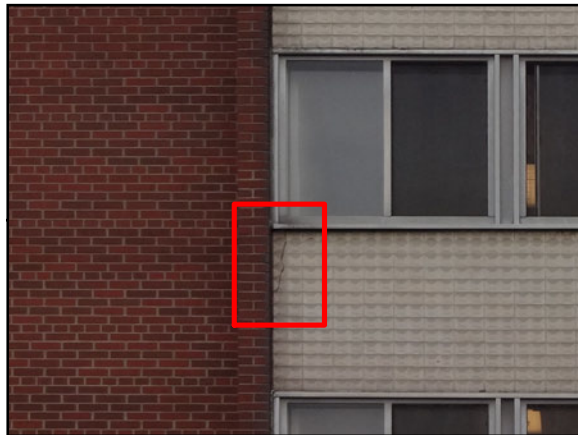
#3: Cracked tiling

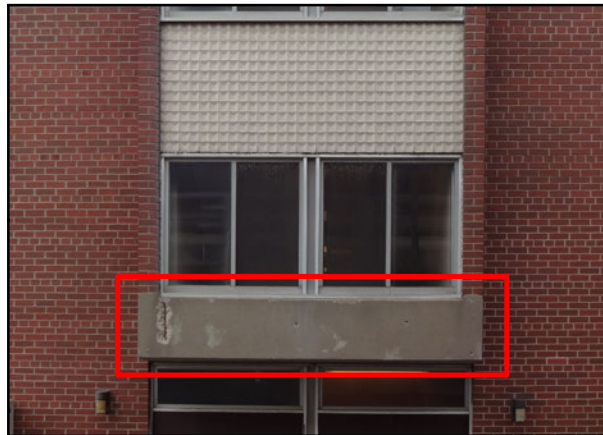
#4: Concrete spalling

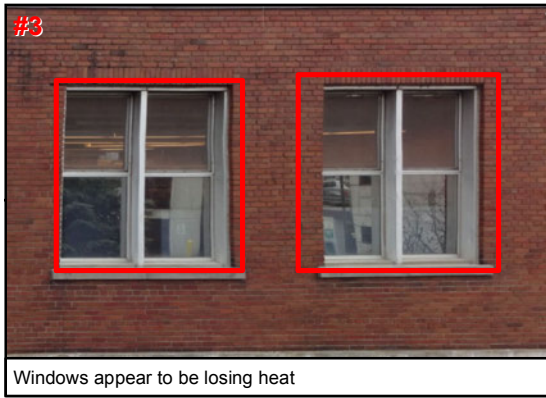
Windows appear to be losing heat

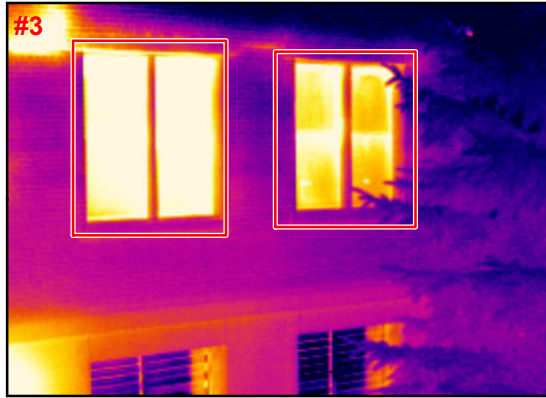
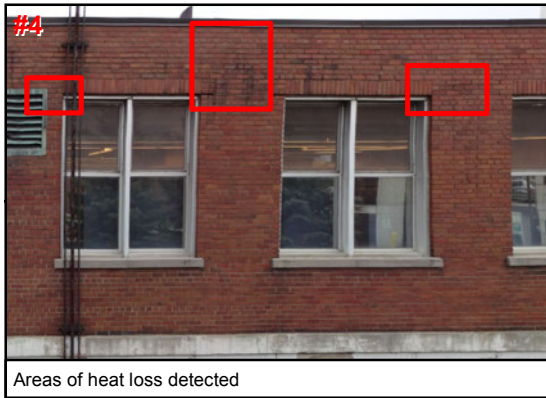
Areas of heat loss detected

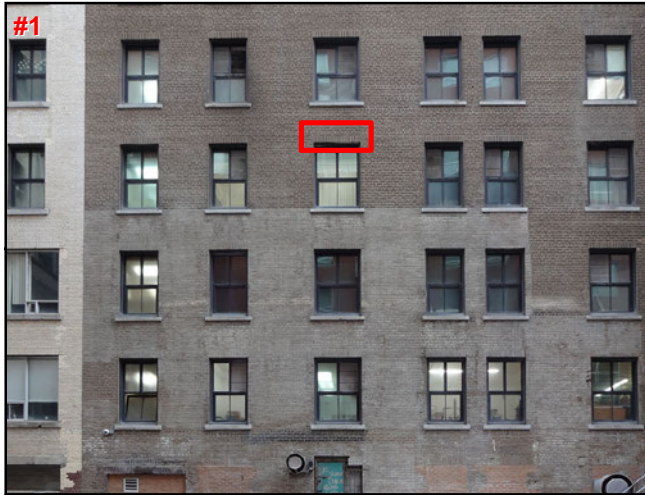
Steel lintel corrosion.

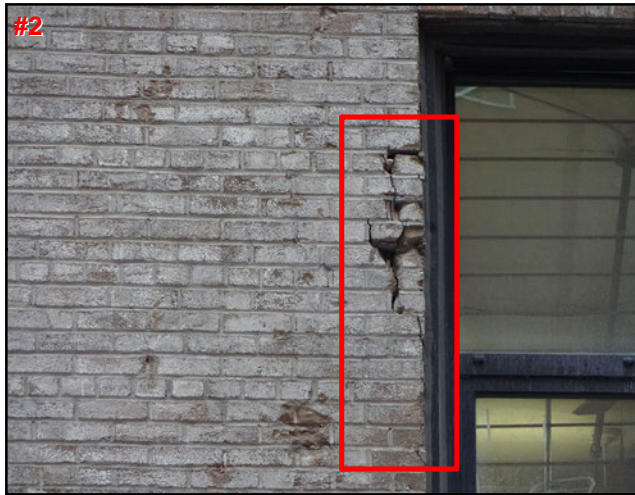
Missing and damaged brickwork.

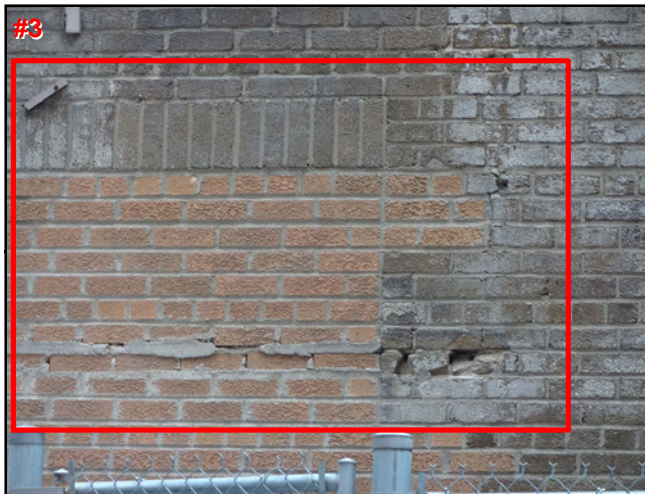
Deficiency in wall fabric increases deterioration of mortar and brick, and promotes water entry.

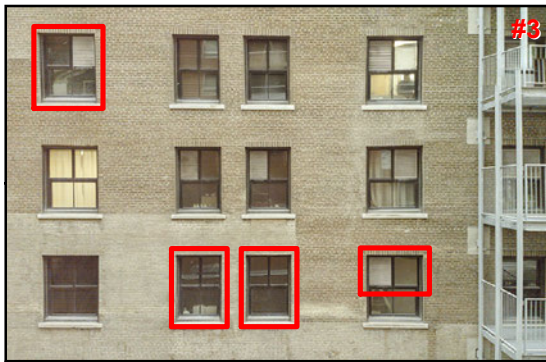
Suspect heat loss from windows.

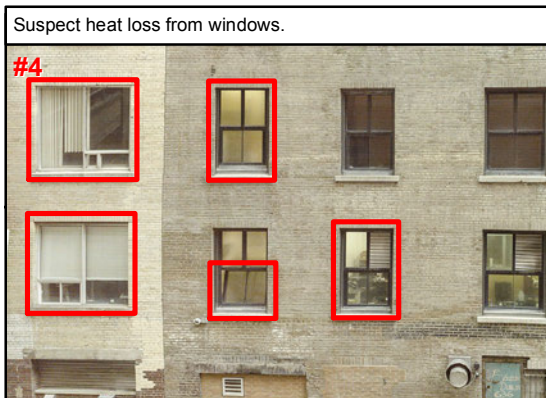
Suspect heat loss from windows.
