Thermographic Roof Report

Avco Industries
22 West Port Drive
Toronto, Ontario

Building Name	Avaco Industries
Building Address	22 West Port Drive
Roofs Scanned:	A and B
Inspection date	Feb 17 2017
Weather Conditions	Sunny 23deg C
Sq.ft of roof scanned	30,000sq.ft
Sq.ft of moisture found	500sq.ft
Total Number of moistures areas found	1

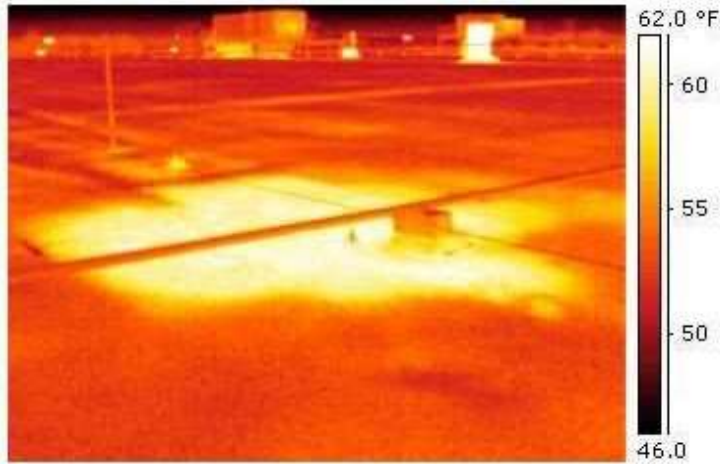
Thermogram #1 Roof A

Roof Name	Anomaly	Sq.ft	Moisture Level
A	#1	500	Wet Insulation
